NIST NCSTAR 1

Final Report on the **Collapse of the World Trade Center Towers**

**National Institute of
Standards and Technology**

September 2005

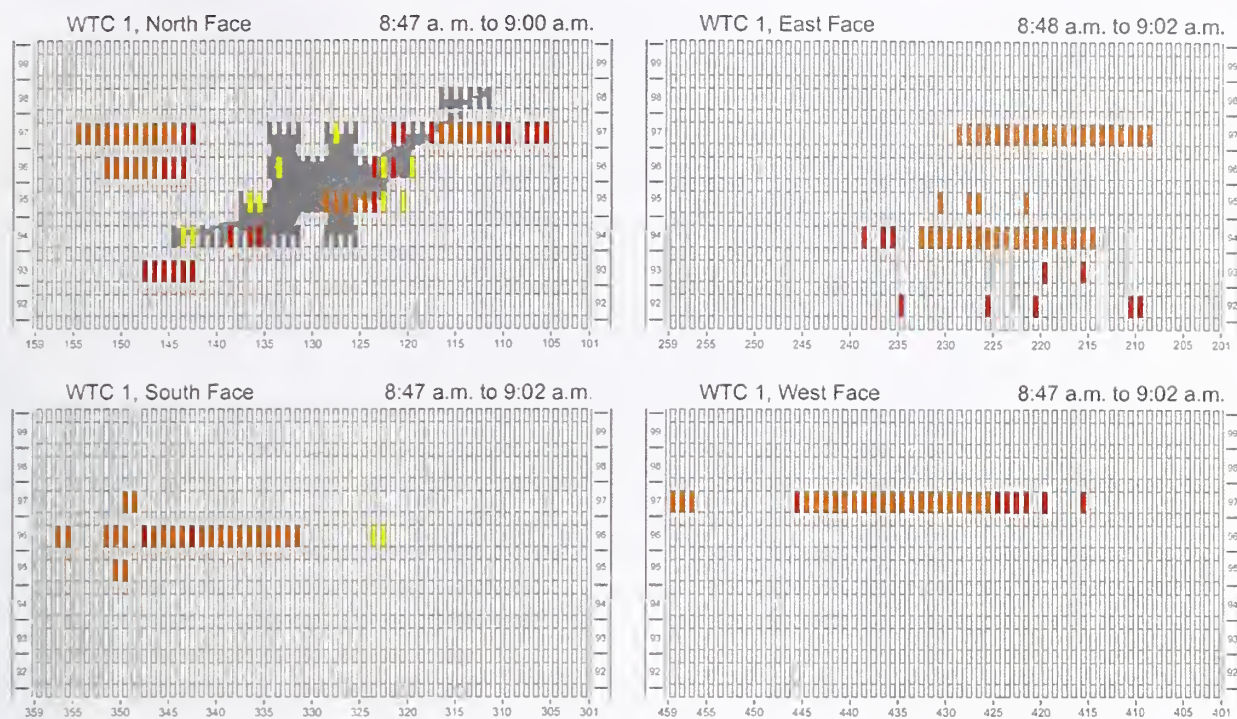
The burning of the jet fuel cloud had consumed much of the oxygen within the 94th and 96th floors, although photographs showing survivors indicated there were some zones with breathable air. The oxygen-starved fires died down, but didn't quite go out. Within the first 2 min after the impact, fires could be seen in the north side windows on the 93rd through 97th floors, the 96th floor of the south face, and the 94th floor of the east face. As fresh air entered the perforated facades, there began the steady burning of the office furnishings and the 13 tons of combustibles from the aircraft that would eventually overwhelm the already damaged building. By 9:00 a.m., these fires had grown and spread to the extent shown in Figure 2-5. In addition to burning around the aircraft entrance hole, there was intense burning on the north, east, and west faces of the 97th floor. Large fires burned on the south side of the 96th floor and the east side of the 94th floor. At 8:52 a.m., a stream of smoke emerged from the south side of the 104th floor, although there was no evidence of a significant fire there yet.

Figure 2-5. Representation of exterior views of the fires on the four faces of WTC 1 from 8:47 a.m. to about 9:02 a.m.

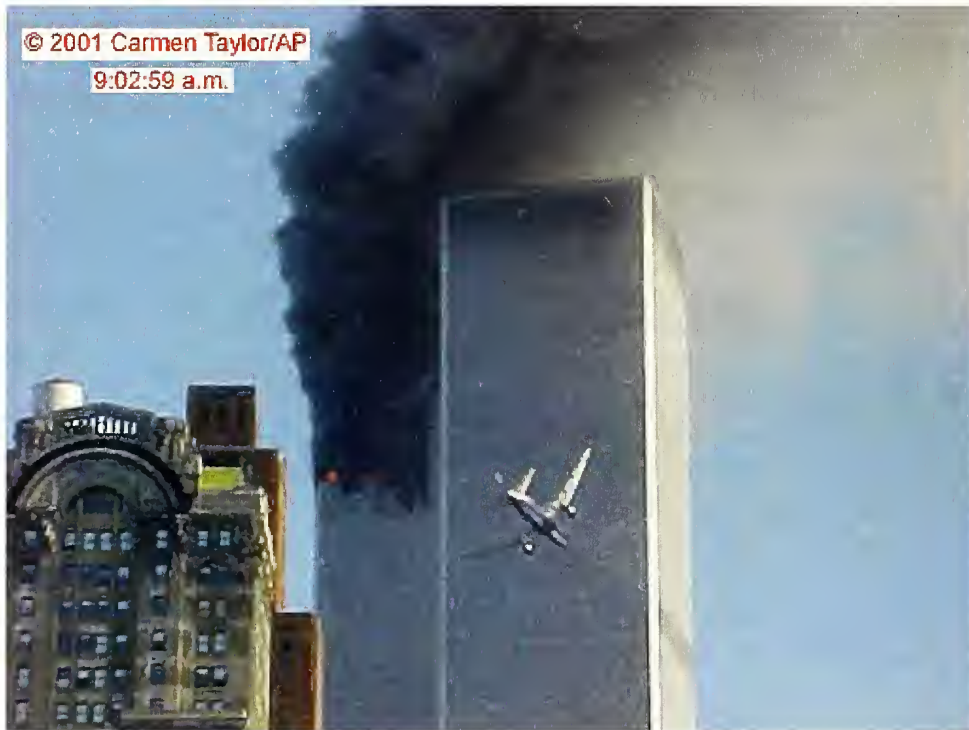
Figure 3–1. Imminent impact of United Airlines Flight 175 with WTC 2.

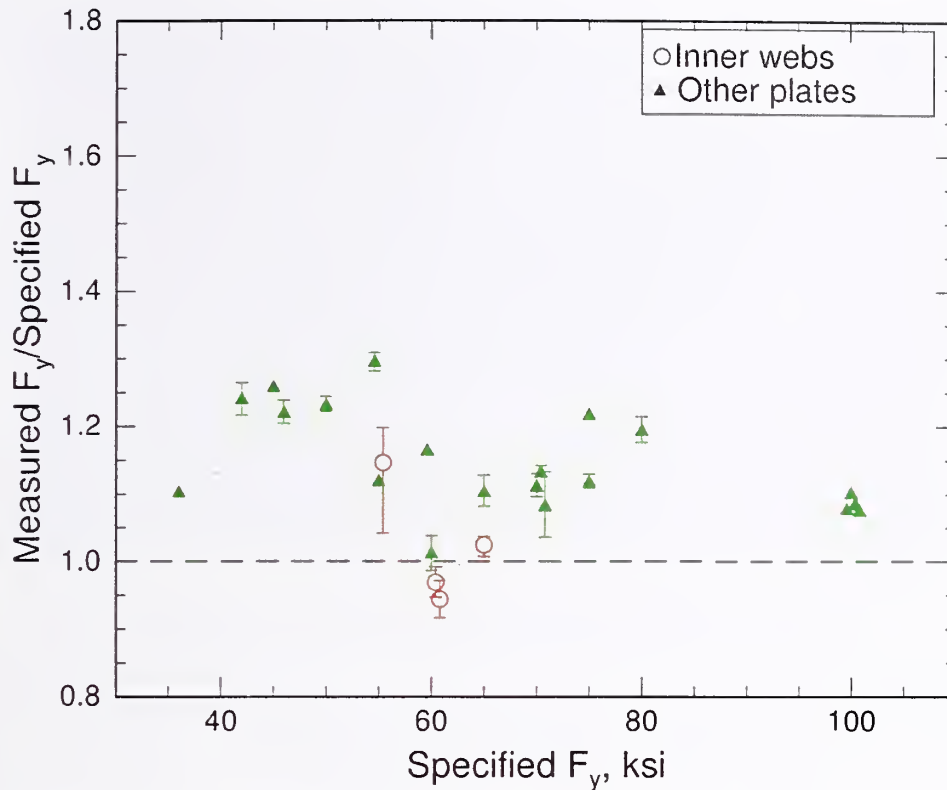
Note: The ratio values less than 1 arose from natural variation in the steel and did not affect the safety of the towers on September 11, 2001. The bars represent maximum and minimum values from multiple measurements.

Figure 5-4. Ratio of measured yield strength (F_y) to specified minimum yield strength for steels used in WTC perimeter columns.

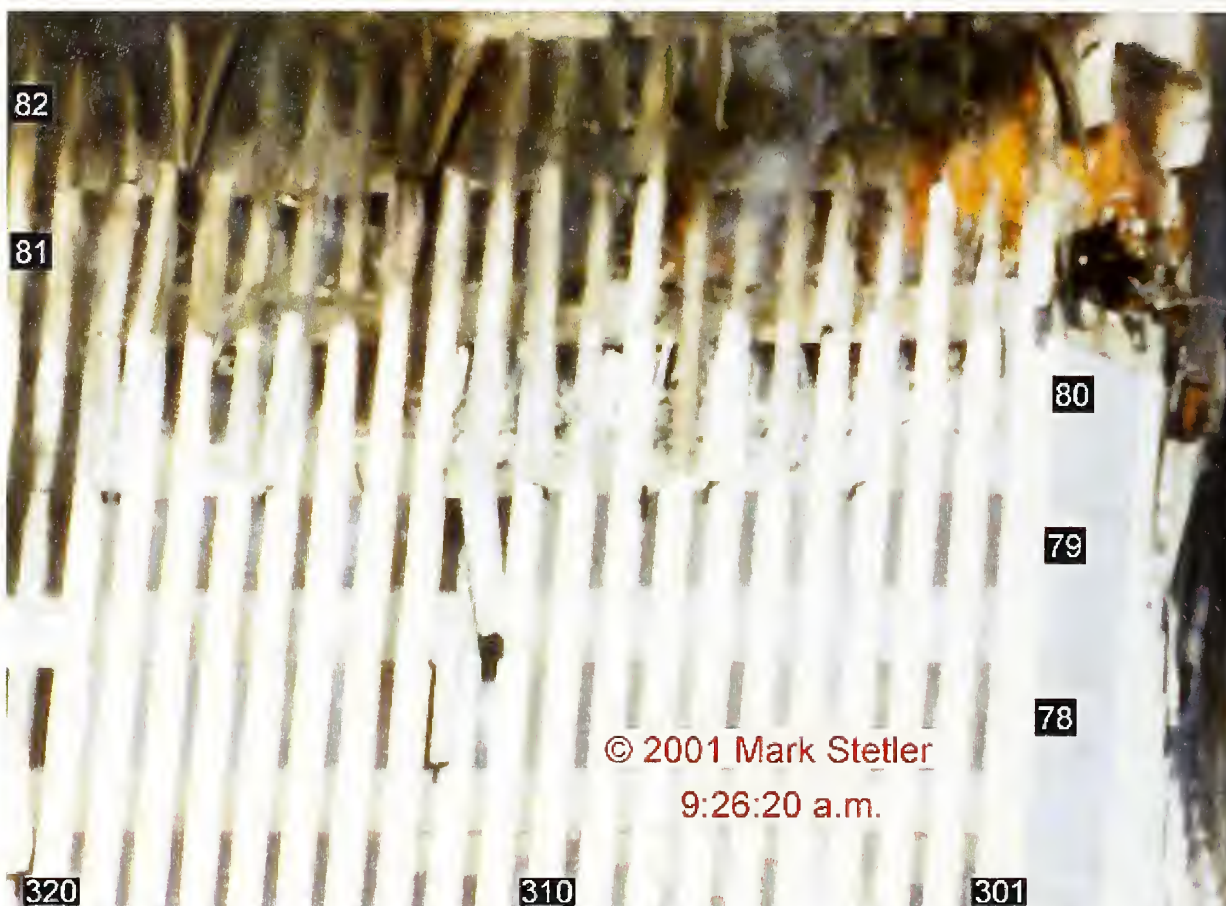
Figure 6–2. Close-up of section of Figure 6–1.

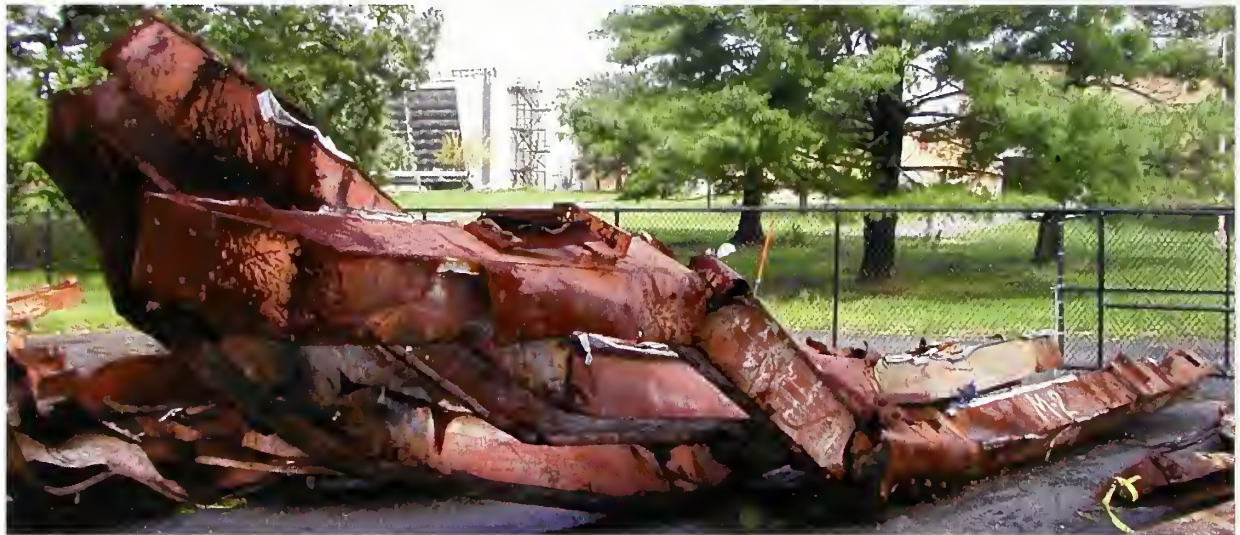
Figure 6-4. WTC 1 exterior panel hit by the fuselage of the aircraft.

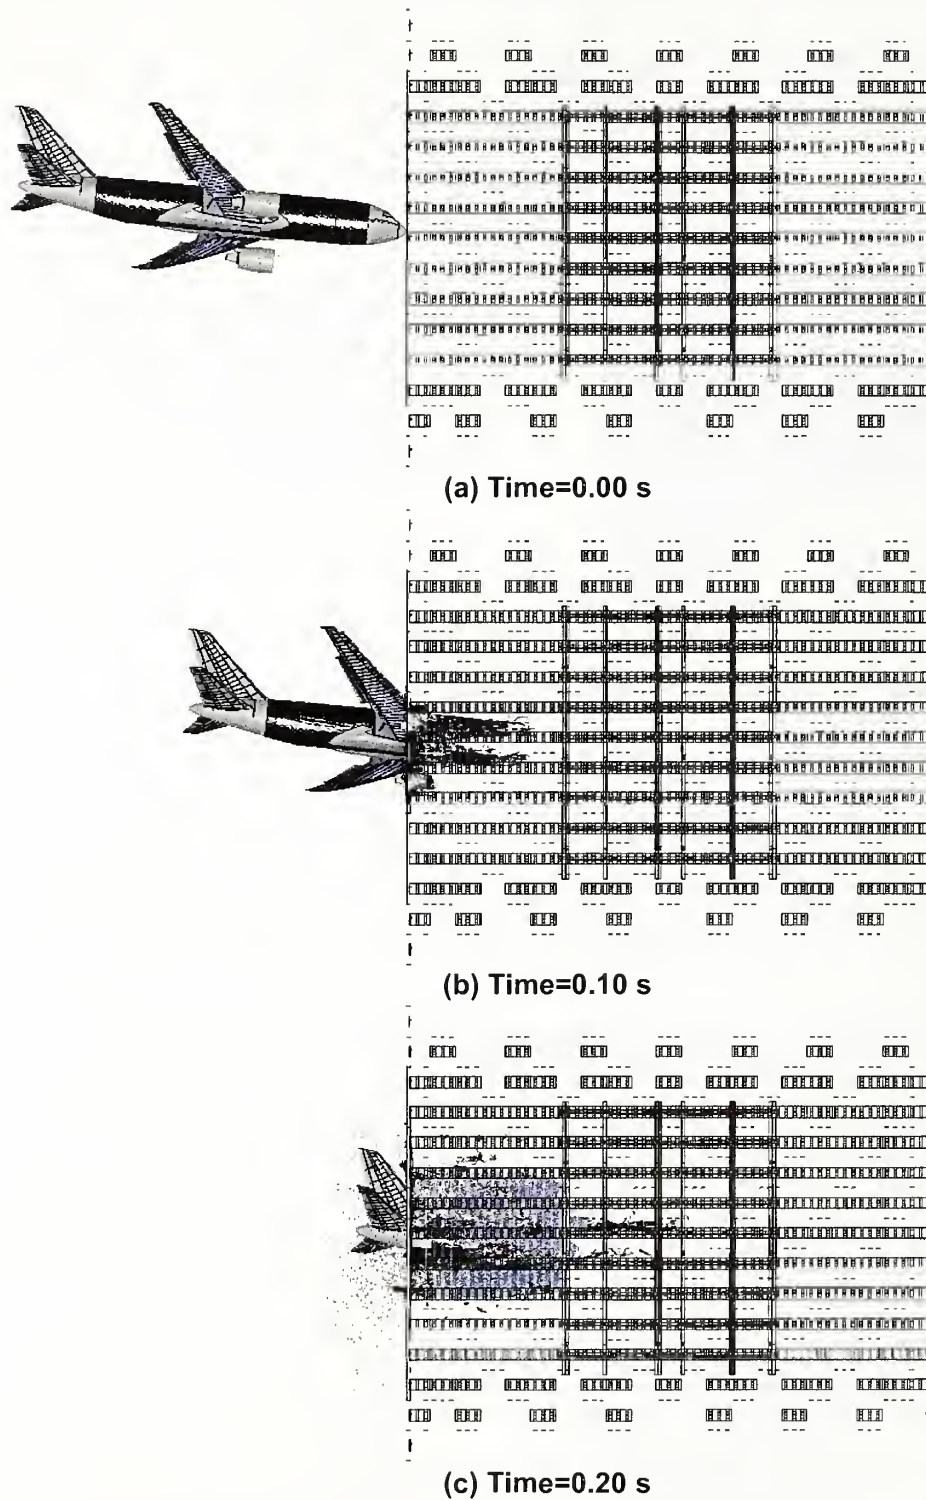
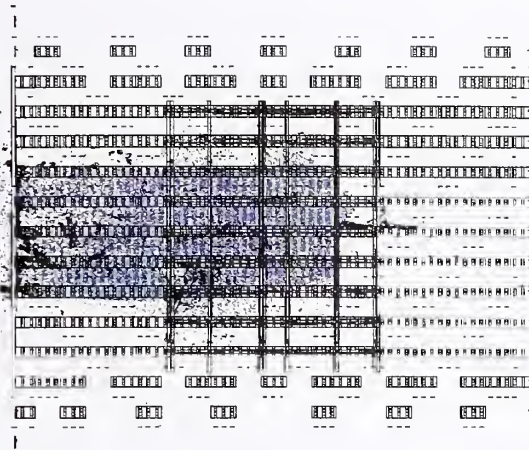
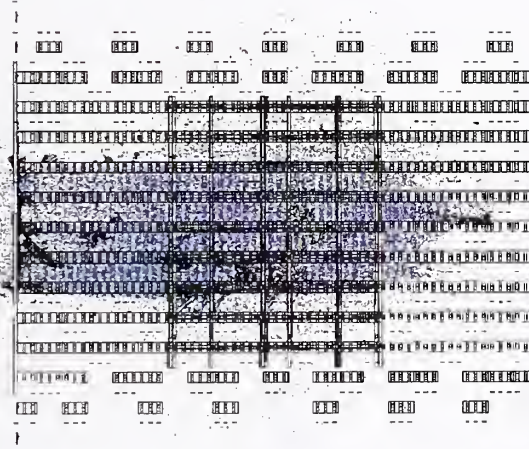
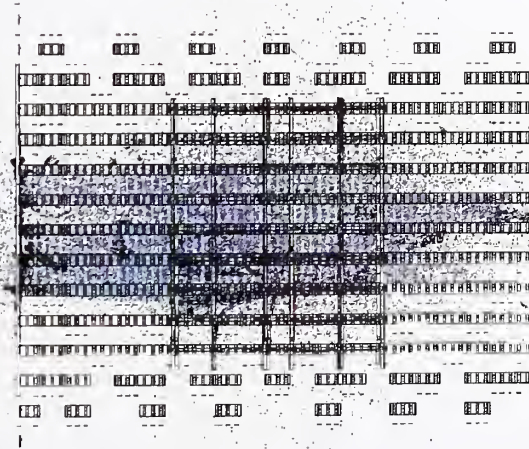
Figure 6–18. Side view of simulated aircraft impact into WTC 1, Case B.

Figure 6–18. Side view of simulated aircraft impact into WTC 1, Case B (Cont.)

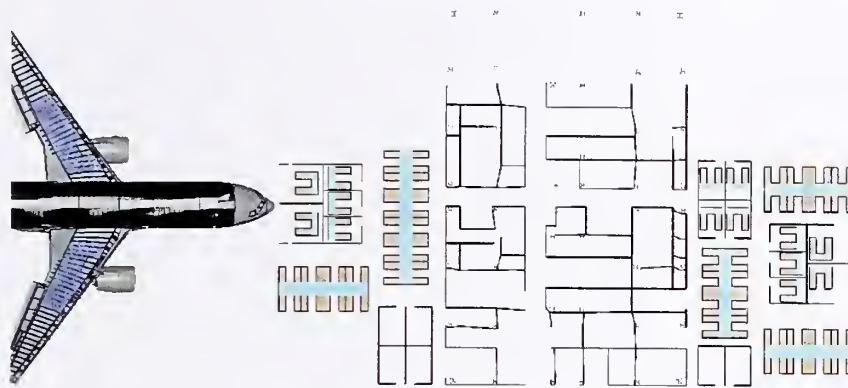
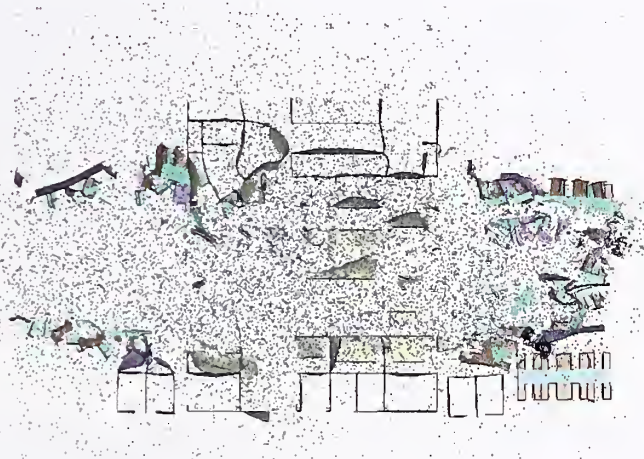
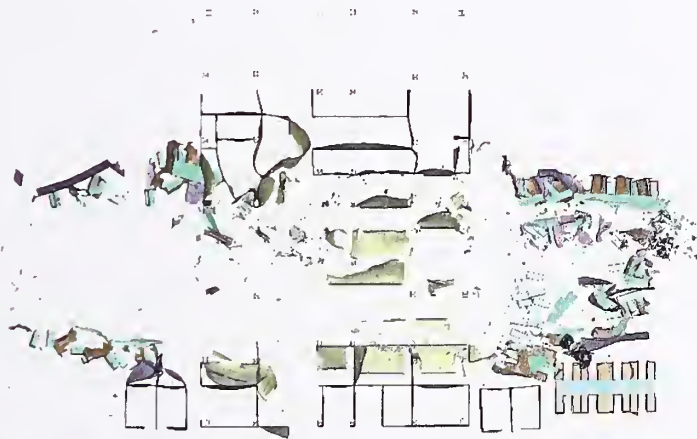
Figure 6–21. Case B simulation of response of contents of 96th floor of WTC 1.

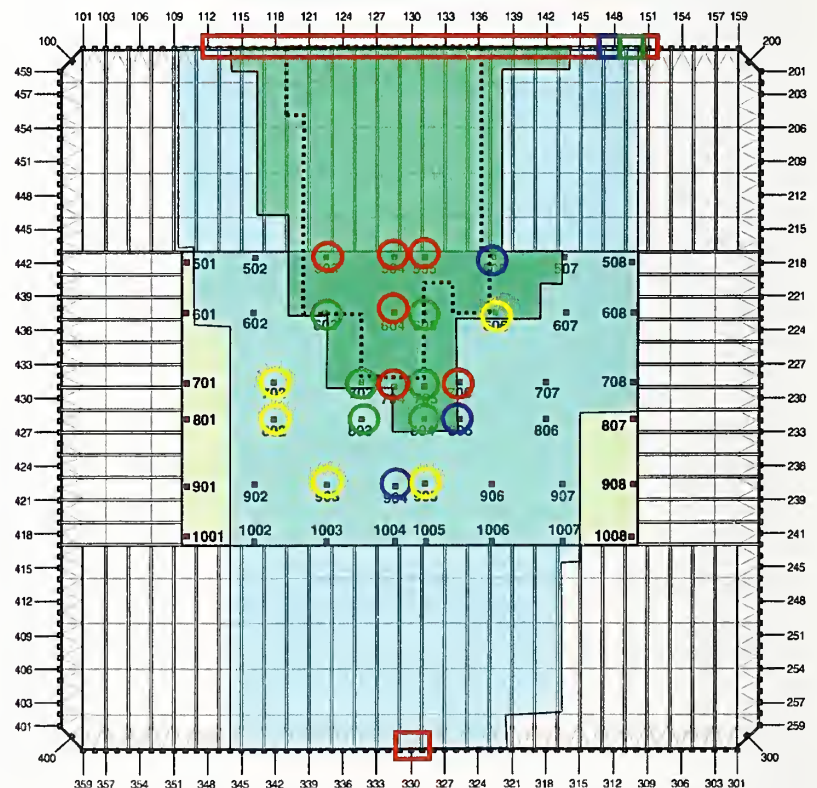
Figure 6-23. Combined structural damage to the floors and columns of WTC 1, Case B.

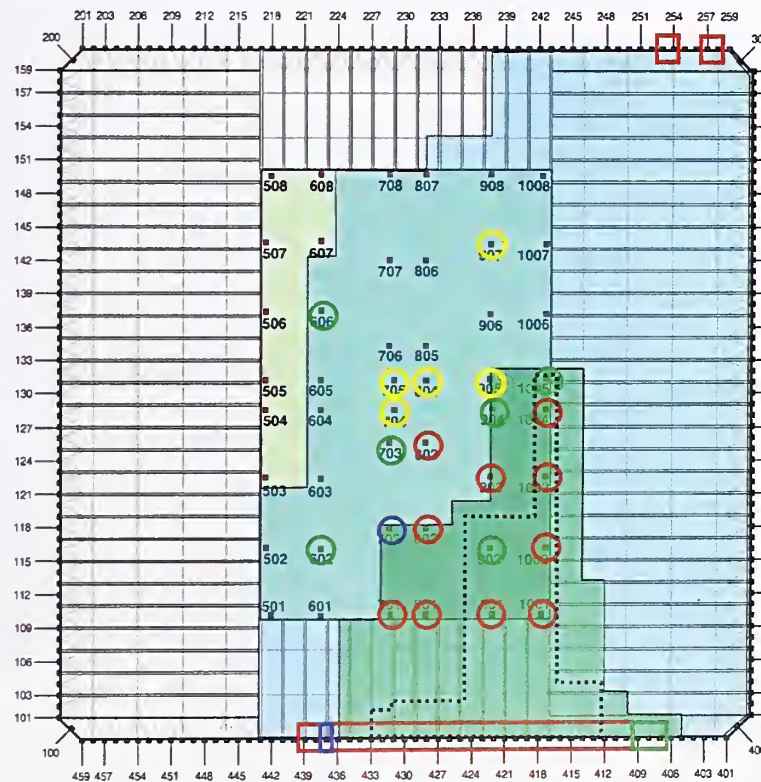
Figure 6-25. Combined structural damage to the floors and columns of WTC 2, Case D.

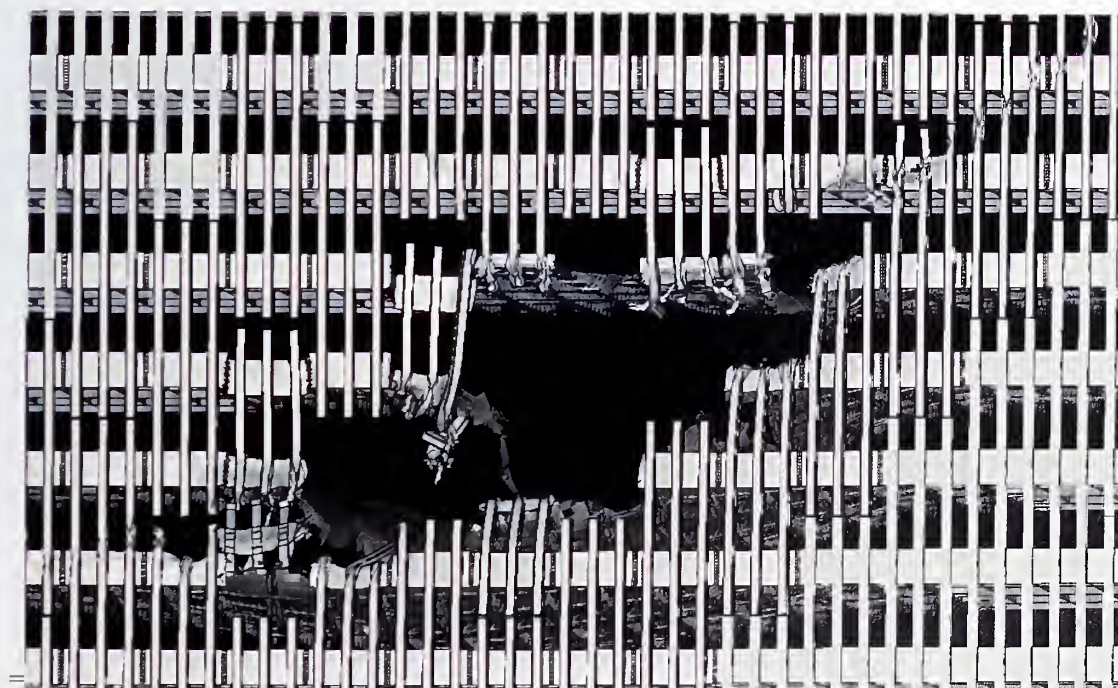
Assessment of the aircraft impact simulations of exterior damage to the towers involved comparing the predicted perimeter wall damage near the impact zone with post-impact photographs of the walls. Figure 6–26 shows a photograph of the north face of WTC 1 after impact and the results of the Case A simulation. The calculated silhouettes capture both the position and shape of the actual damage.

Figure 6–26. Observed and Case A calculated damage to the north face of WTC 1.

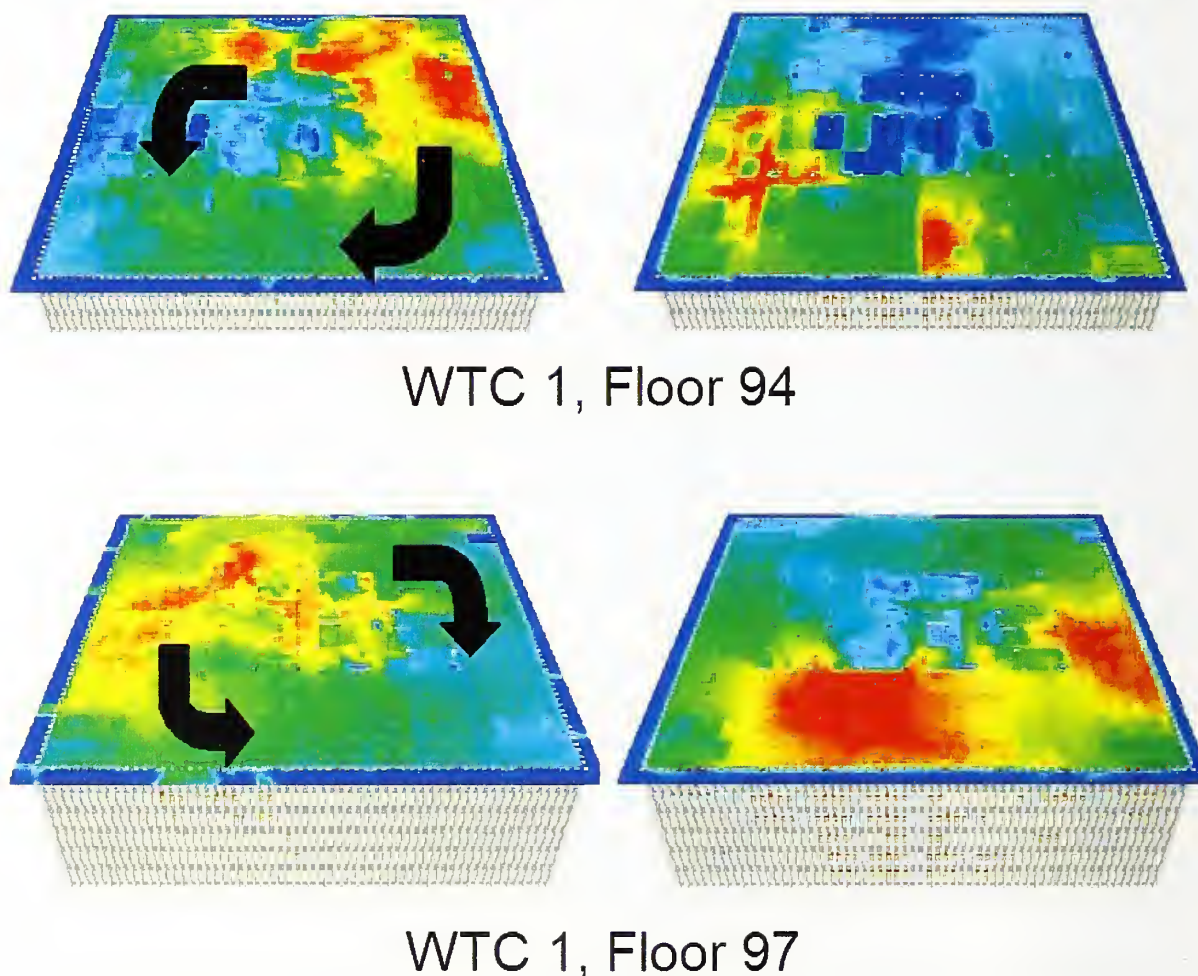
Much of the fire activity was initially in the vicinity of the impact area in the north part of the building. As a result of the orientation of the impacting aircraft and its fuel tanks, the early fires on the 92nd through 94th floors tended toward the east side of the north face, while the early fires on the 97th through 99th floors tended toward the west side of the north face. The fires on all the floors spread along the east and west sides and were concentrated in the south part of the building at the time of collapse, as depicted in Figure 6–37.

Figure 6–37. Direction of simulated fire movement on floors 94 and 97 of WTC 1.

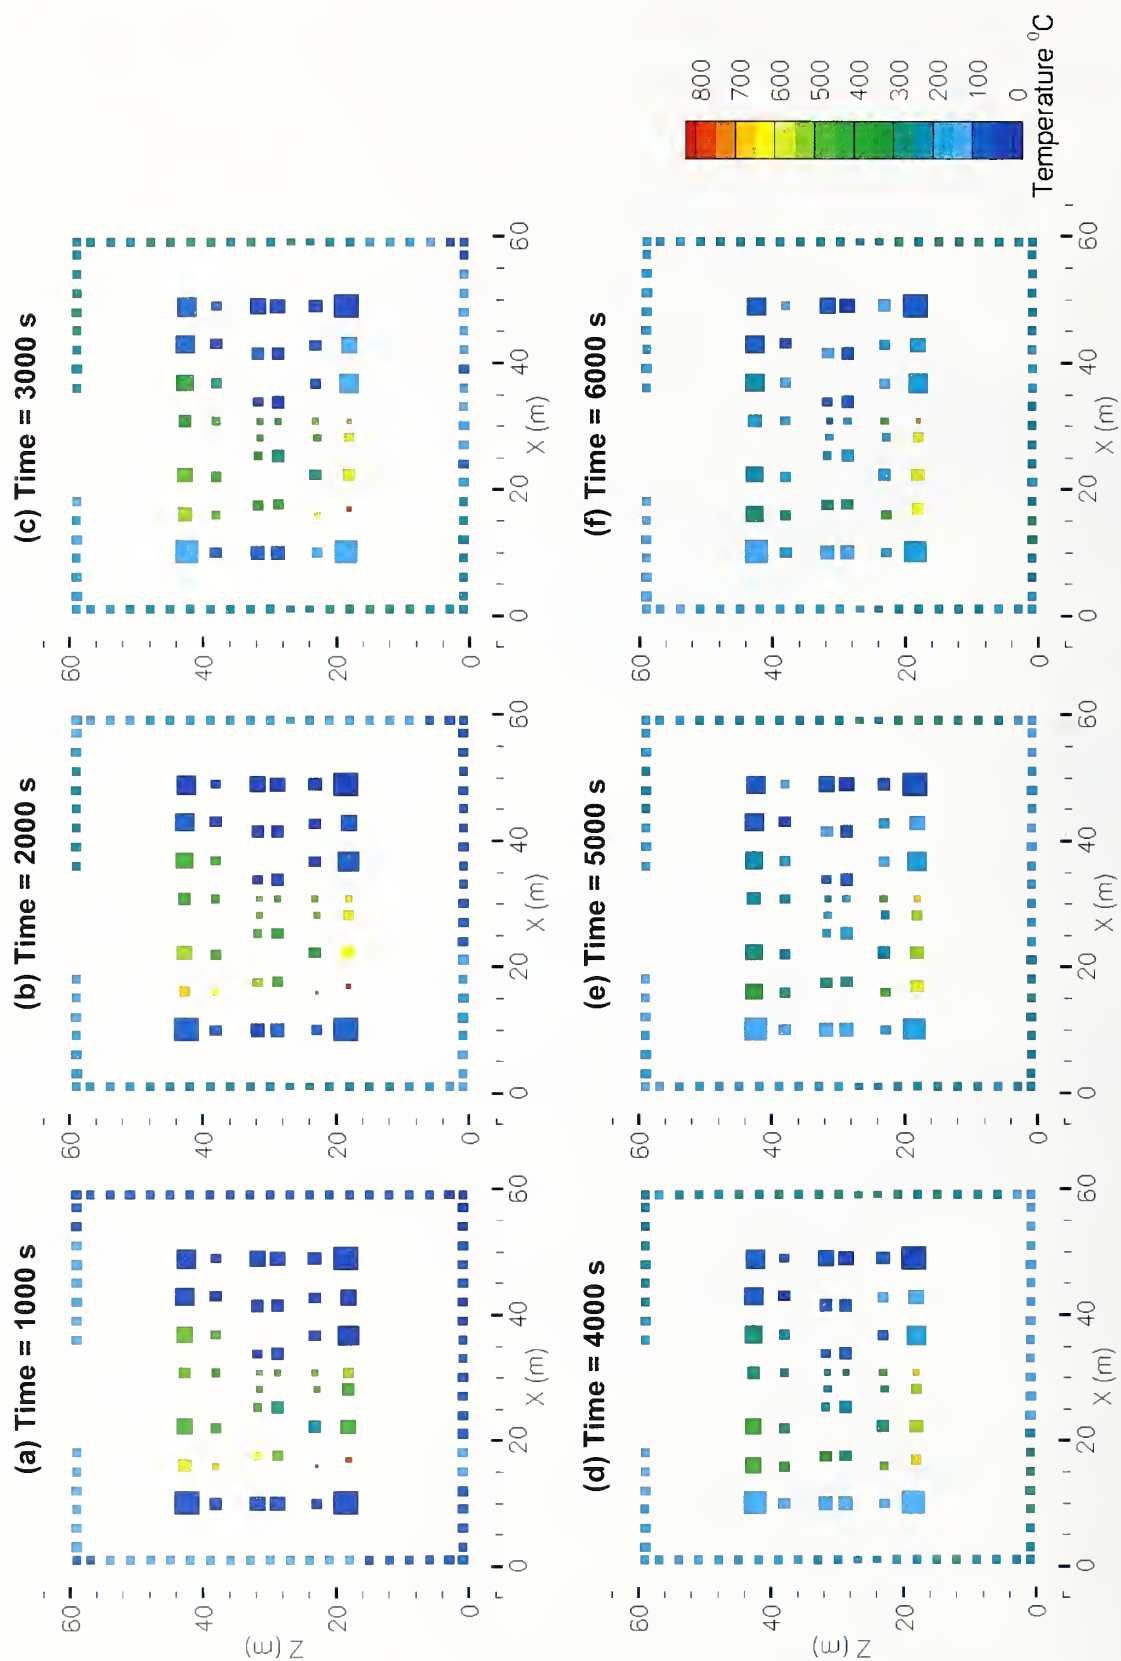
A third visualization tool was animation of the evolving temperatures of the columns. Frames from an example, again of the 96th floor of WTC 1, Case A, are shown in Figure 6–48. The size of the square representing a column represents its yield strength. Columns may have been heated when the fire was nearby and then cooled after the local combustibles were consumed.

Figure 6-48. Frames from animation of the thermal response of columns on the 96th floor of WTC 1, Case A.

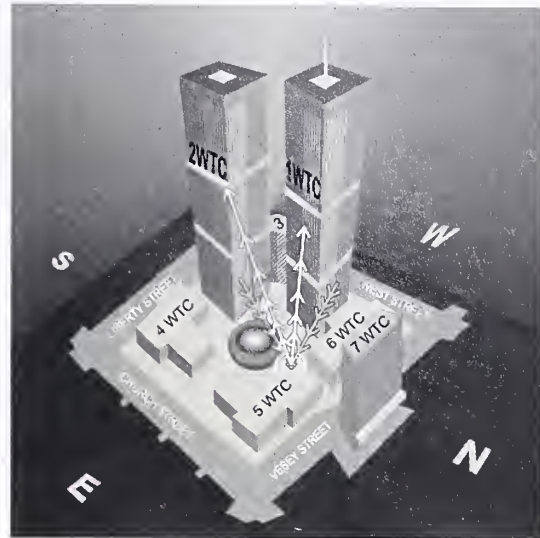
- Established a PAPD Command Center inside of WTC 5.
- Installed Fire Command Desks in the lobbies of WTC 1 and WTC 2.
- Installed in WTC 5 a radio repeater that operated on the FDNY city-wide high-rise frequency. (The radio repeater's function was to receive FDNY radio communication on a specified radio frequency, amplify the signal power, and retransmit the radio communications on another specified radio frequency that the FDNY radios could receive. This could enhance communications in buildings made of steel and reinforced concrete that pose challenges to radio-frequency communication.) The antenna was located on the top of WTC 5 and was directed at WTC 1 and WTC 2 (Figure 7–5). On September 11, 2001, the controls for operating the repeater were located at the Fire Command Desks in the tower lobbies.

Figure 7–5. Location of the radio repeater.

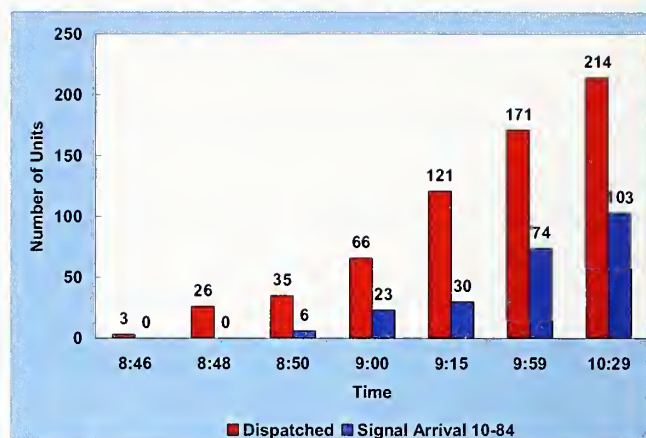
The emergency response to the attack was immediate. Within 3 min of the aircraft impact on WTC 1, PAPD was providing information on the attack to the police desk, FDNY had dispatched 26 units to the scene, and NYPD had called a department mobilization that included dispatching aviation units to the WTC for visual assessment. Within 10 min, PAPD had called a chemical mobilization; NYPD had dispatched five Emergency Service Unit (ESU) teams and had two aviation units at the scene providing observations. Within 30 min, 121 FDNY units had been dispatched to the scene and 30 units had signaled their arrival at the scene by pushing the “10-84” button on the vehicle’s communications console (Figure 7–6).

Figure 7–6. Timing of FDNY unit arrivals.

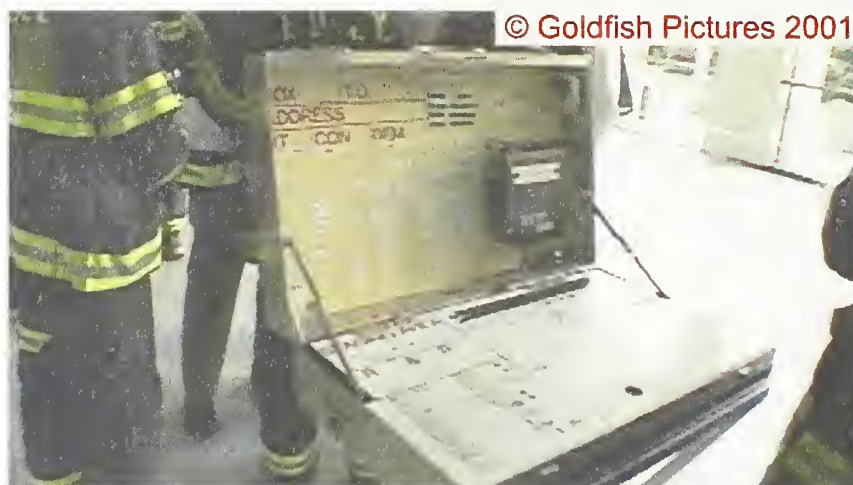
Thus, keeping track of what all these people were doing, where there were located, where they were going, and what they would do when they got there was a task without precedent. The principal tools for this were three 18 in. x 28 in. magnetic boards known as Fire Command Boards (Figure 7–7). They were located in the lobbies of WTC 1 and WTC 2 and at the Incident command Post on West Street. On each Board, magnetic identifiers of different colors identified engines, ladder and tower ladders, battalions, special units, and sectors. Unit numbers were written on the identifiers with marking pens. These Boards became overwhelmed after about 30 min due to the large number of people and units arriving at the scene. Some emergency personnel that arrived at the site did not report to the Command Posts or were not logged in on the Command Board. A formal analysis of arrivals and missions of the various units was compromised by the loss of the Boards in the collapse of the towers; there were no backup records.

Figure 7–7. Fire Command Board located in the lobby of WTC 1.
